CENTRAL STATES FOREST EXPERIMENT STATION
COLUMBUS, OHIO

June 1963

CS-7

USE AIR-DRY DECKBOARDS FOR BETTER WOODEN PALLETS

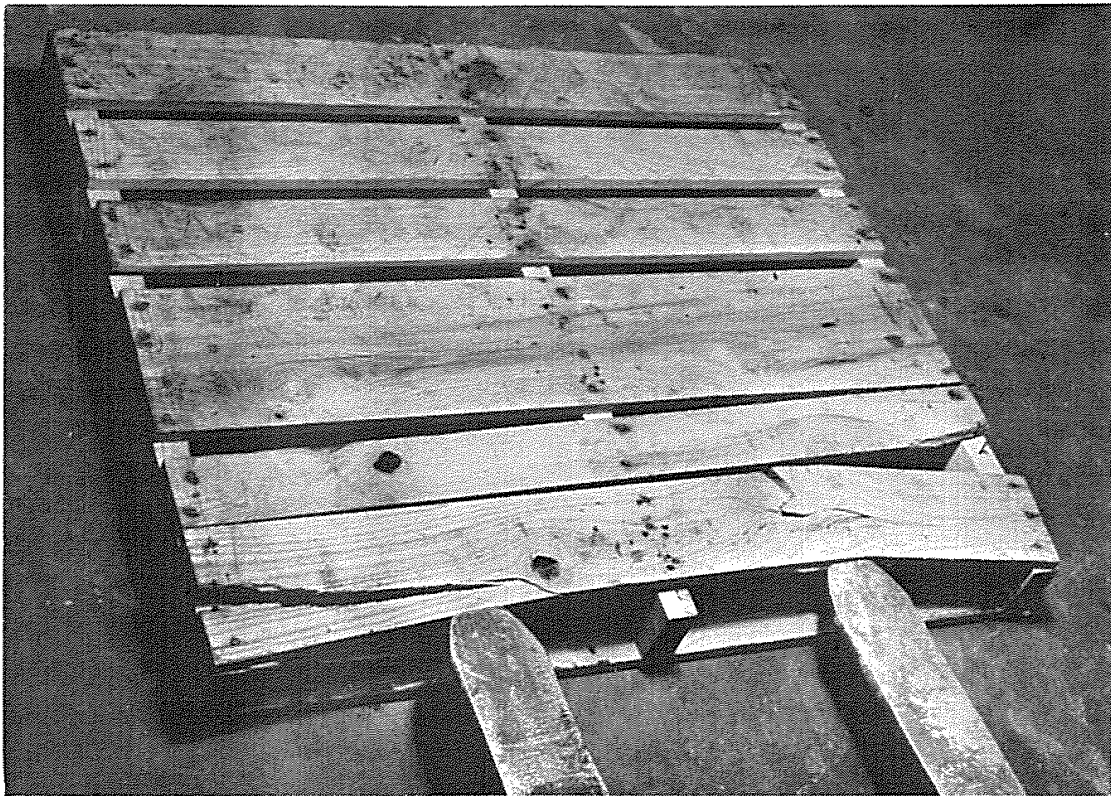
The 90 pallets are being used in the apple-processing plant of Eckert Orchards, Incorporated, Carbondale, Illinois. During the first year of the test, the plant operated intermittently for a total of 165 days and the pallets were moved an average of 0.6 times per day. Six pallets were accidentally damaged when rammed by lift-truck forks. Breakage in these pallets was confined to top edge deckboards and, in two cases, to an adjacent top deckboard (fig. 1). These pallets were repaired and placed back in service.

Figure 1.--A typical accidental ramming failure.

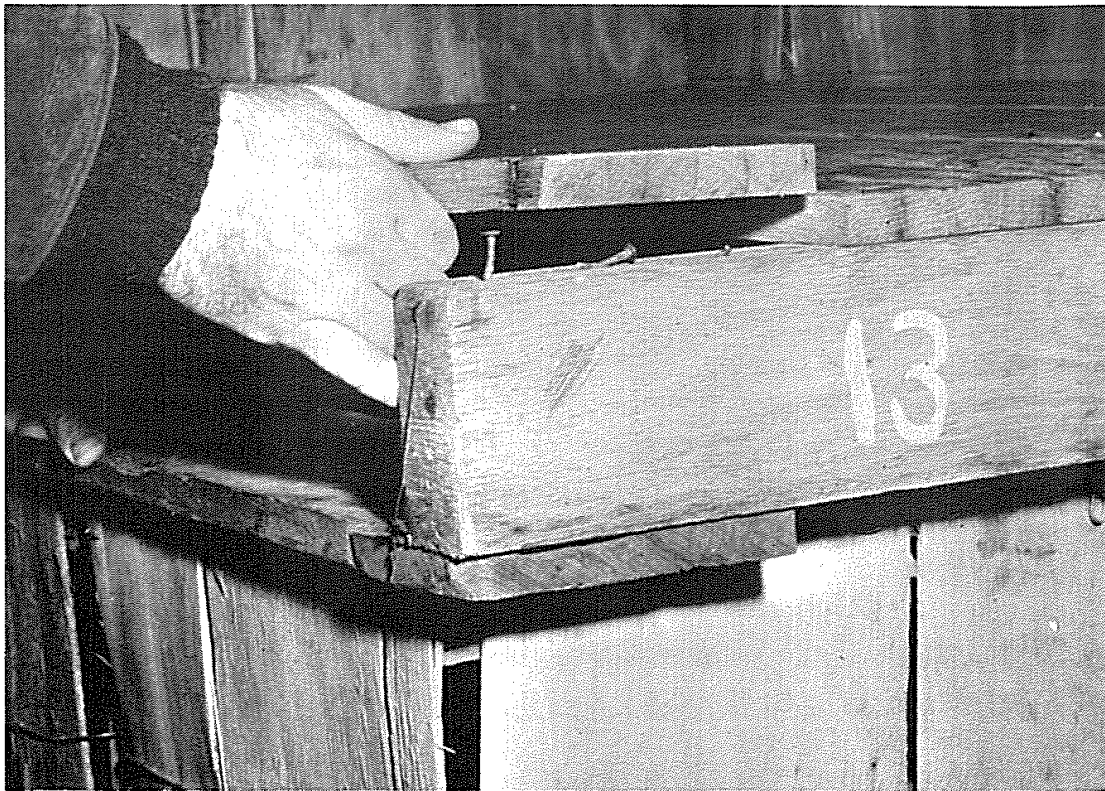
Excluding the accidental damage, ten pallets failed during normal use. Eight of these were all-green pallets, one was an all-dry pallet, and the other was a dry-green pallet. Failures consisted of complete separation of a top edge deckboard from one or more stringers due to nails either pulling through the deckboard or shearing off (fig. 2). In no case did a nail pull out of a stringer.

Failures resulted primarily from the prying action of lift-truck forks and appeared to be closely related to splits or through-checks at the nails. There were four times as many splits or through-checks at the nails in green deckboards as in dry deckboards.

When the edge deckboard was split or checked at the nails, the nails most often bent or pulled through the deckboard. If the deckboard was not split or checked, the nails usually sheared off between the stringer and the deckboard. The type of nail failure also depended on the location of nails in edge deckboards: nails closest to the leading or front edge of the deckboard most often pulled through, while those nearest the trailing or back edge of the deckboard usually sheared off (fig. 2). Failure of nails at the center of the 5 1/2-inch-wide edge deckboards was about equally divided between pull-through and shearing. It appeared that when splits were present at the nails in edge deckboards, the prying action of the lift-truck forks caused the leading edge nails to begin pulling through the deckboard. The resulting increased load on the trailing edge nails tended to shear them off. Since splits were more prevalent in green deckboards, this failure happened most often in pallets fabricated with green decks.

Figure 2.--A typical normal use failure.

A comparison of failures in the test pallets during the first year of use indicates that the advantages of using air-dry lumber for deckboards might well offset the added initial cost of pallets with dry decks. Except for minor nail-popping, there was no noticeable difference in pallet performance due to initial moisture content of stringers, but this factor might become important with further use. Pallets with loose deckboards were repaired and returned to service. We will continue to observe and record performance through at least one more season of use.
